Revision Guide for AMD Family 15h Models 10h-1Fh Processors

Publication # 48931	Revision: 3.08
Issue Date: August 2012

Advanced Micro Devices

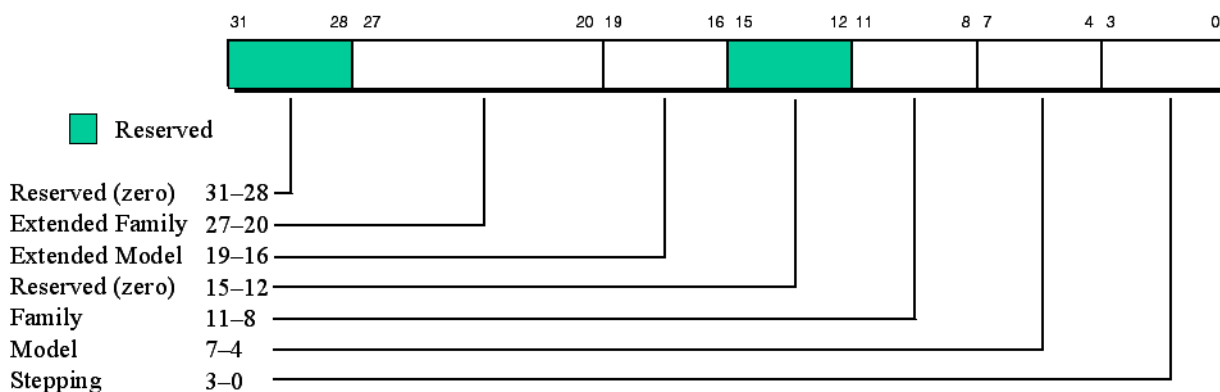
Figure 1. Format of CUID Fn0000_0001_EAX

A processor revision is identified using a unique value that is returned in the EAX register after executing the CUID instruction function 0000_0001h (CUID Fn0000_0001_EAX). Figure 1 shows the format of the value from CUID Fn0000_0001_EAX. In some cases, two or more processor revisions may exist within a stepping of a processor family and are identified by a unique value in D18F4x164 Fixed Errata Register (see D18F4x164 Fixed Errata Register).
