Revision Guide for AMD Family 16h Models 00h-0Fh Processors

Publication # 51810	Revision: 3.06
Issue Date: June 2013

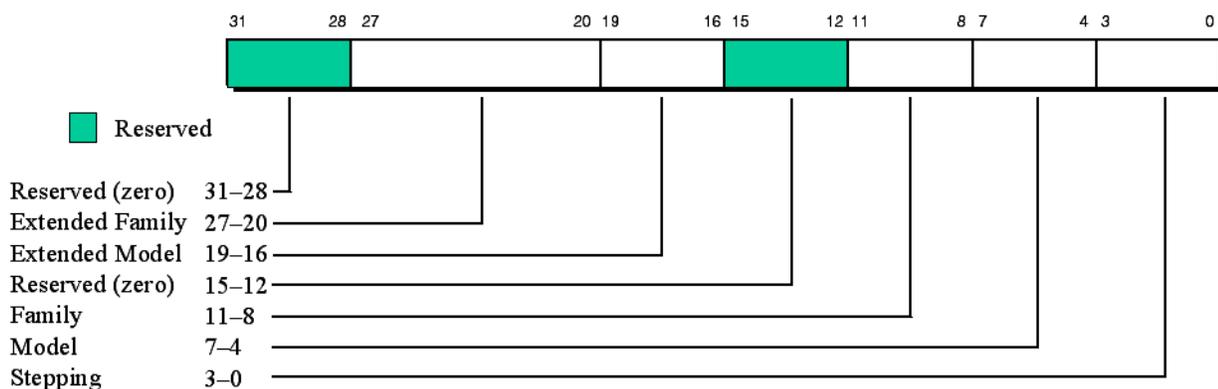
Figure 1. Format of CPUID Fn0000_0001_EAX

A processor revision is identified using a unique value that is returned in the EAX register after executing the CPUID instruction function 0000_0001h (CPUID Fn0000_0001_EAX). [Figure 1](#) shows the format of the value from CPUID Fn0000_0001_EAX. In some cases, two or more processor revisions may exist within a stepping of a processor family and are identified by a unique value in D18F4x164 Fixed Errata Register (see [D18F4x164 Fixed Errata Register](#)).
