Revision Guide for AMD Family 15h Models 00h-0Fh Processors

Publication # 48063 Revision: 3.04 Issue Date: November 2011
--

Advanced Micro Devices

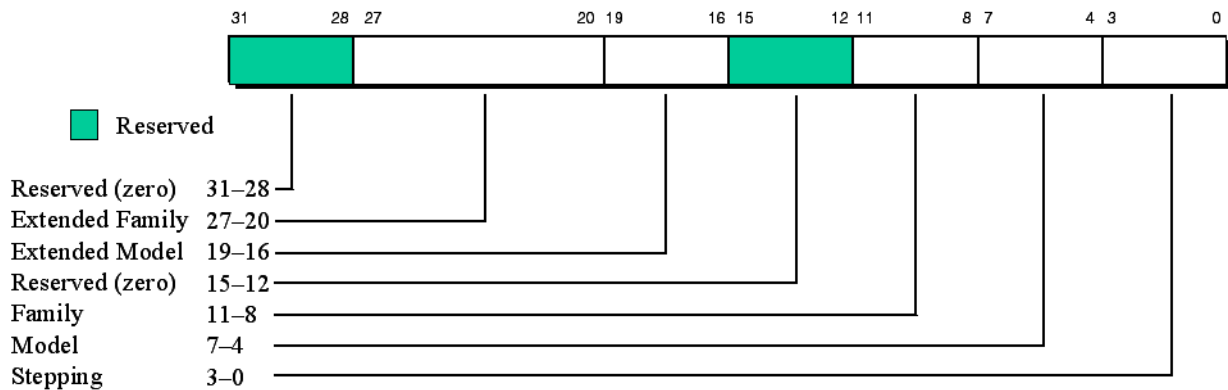
Figure 1. Format of CPUID Fn0000_0001_EAX

A processor revision is identified using a unique value that is returned in the EAX register after executing the CPUID instruction function 0000_0001h (CPUID Fn0000_0001_EAX). [Figure 1](#) shows the format of the value from CPUID Fn0000_0001_EAX. In some cases, two or more processor revisions may exist within a stepping of a processor family and are identified by a unique value in D18 F4x164 Fixed Errata Register (see [D18F4x164 Fixed Errata Register](#)).

[Table 2](#) through [Table 4](#) cross-references the identification number from CPUID Fn0000_0001_EAX and D18F4x164 (if necessary) for each revision of the processor to each processor segment. "X" signifies that the revision has been used in the processor segment. "N/A" signifies that the revision has not been used in the processor segment.
